TRAINING BULLETIN

#TB10007

AC1330 SERIES COMPRESSOR AIR
REGULATOR LEAKING

AC138HEG2
AC1330HEB2
AC1330HEBG2S
AC1330HB3000W

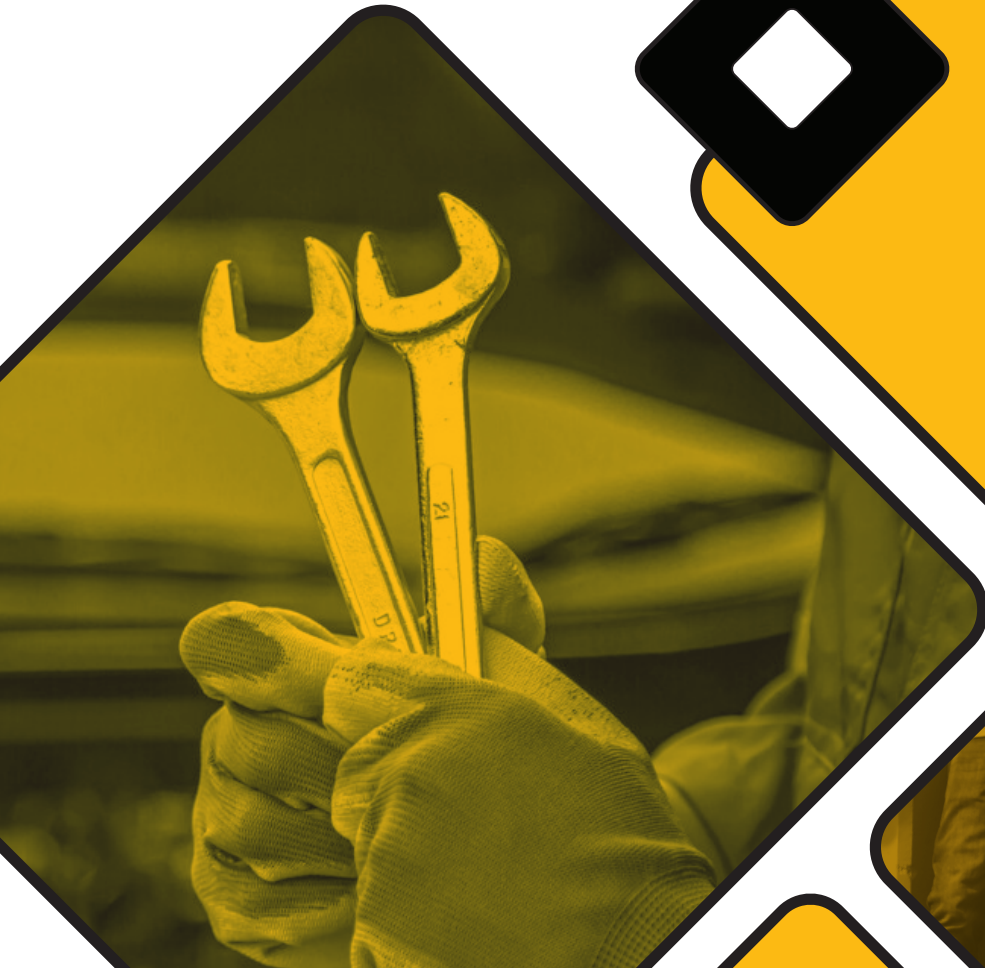
THE ABOVE MODELS OF AIR COMPRESSORS CAN BE AFFECTED BY A FAILURE OF THE AIR REGULATOR LEAKING AIR FROM THE BODY OF THE REGULATOR EITHER FROM NEW OR SHORTLY INTO USE OF THE COMPRESSOR. THE FAILURE HAS BEEN SOURCED TO THE SCREWS THAT HOLD THE BODY TOGETHER COME LOOSE AND THE DIAPHRAGM SEAL IS PUSHED OUT OF PLACE ALLOWING THE AIR TO LEAK THROUGH.

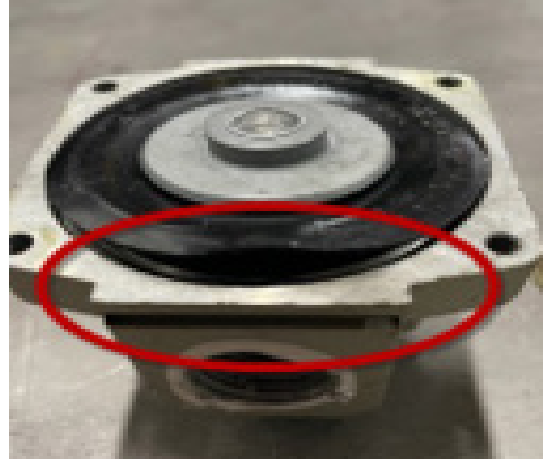
3. You will notice the area of the diaphragm that has been allowed to fold up from the loose screws
